Manhole Inspection Summary

Manhole # S39A__008MH

Insp Date: **11/19/08 10:55 AM**

Location Address: **520 ensor st**

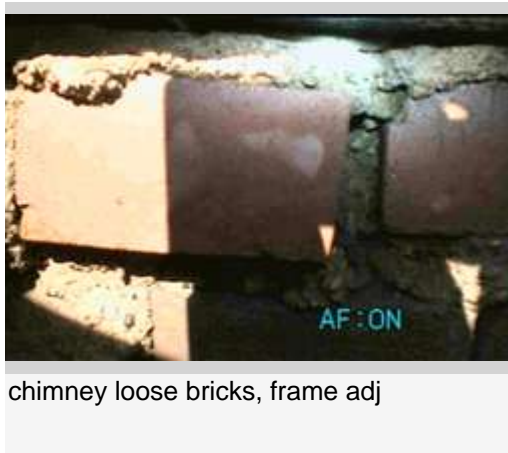
Defect 4

Chimney / Frame Adjustment ☒ Exists Material: **Brick and Concrete** ☐ Parged Height: **8** (in.)

Condition: ☐ Sound ☐ Cracked ☐ Root Intrusion ☒ **Loose Brick** ☒ **Deteriorated**

chimney loose bricks, frame adj

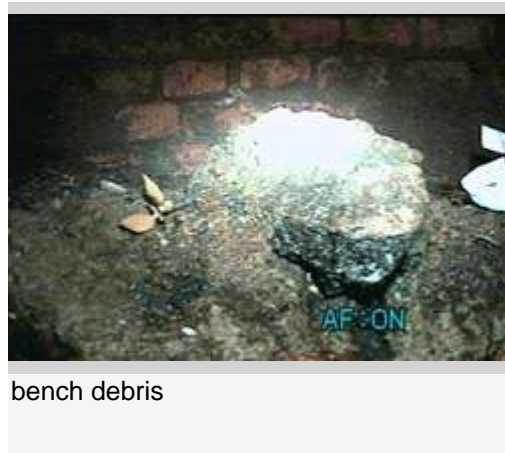
Defect 3

Condition: ☐ Sound ☐ Cracked ☐ Root Intrusion ☐ Deteriorated ☐ Leaks ☒ **Debris**

bench debris

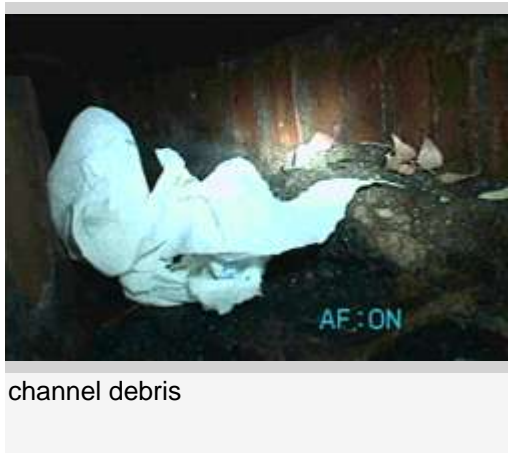
Defect 2

Condition: ☐ Sound ☐ Cracked ☐ Root Intrusion ☐ Deteriorated ☐ Leaks ☒ **Debris**

channel debris

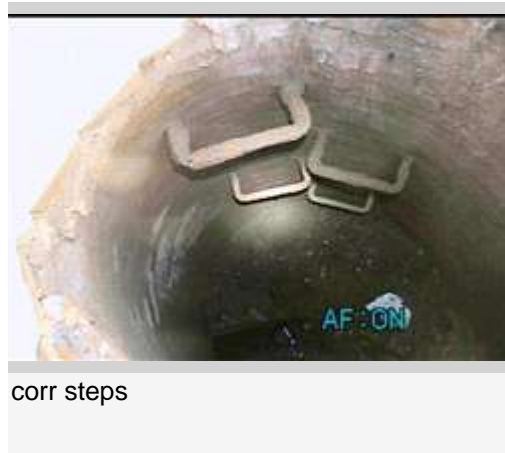
Defect 1

Steps Count: **4** Missing: **0** ☒ **Corroded**

corr steps
